Deer Creek Road Boulder Creek, CA

RE: Condition and evaluation of existing bridges

Owners Name Deer Creek Rd Association

Date: July 28, 2012

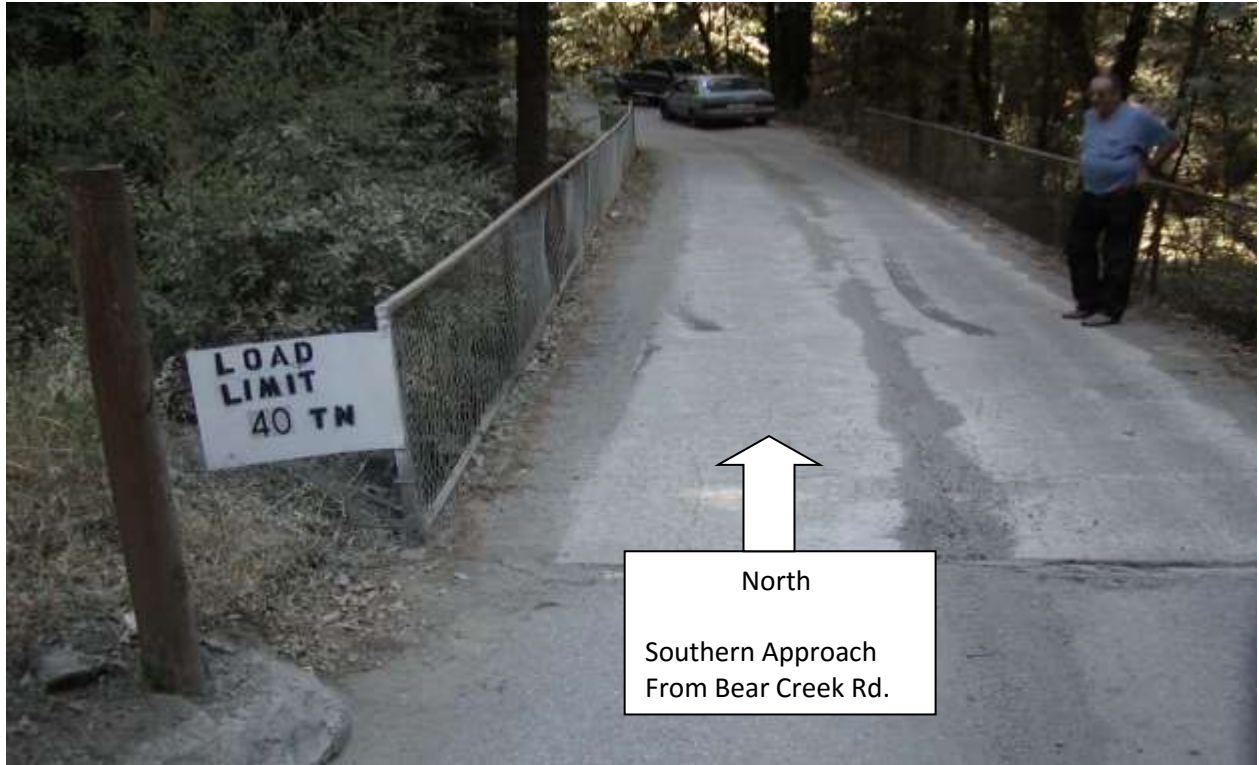
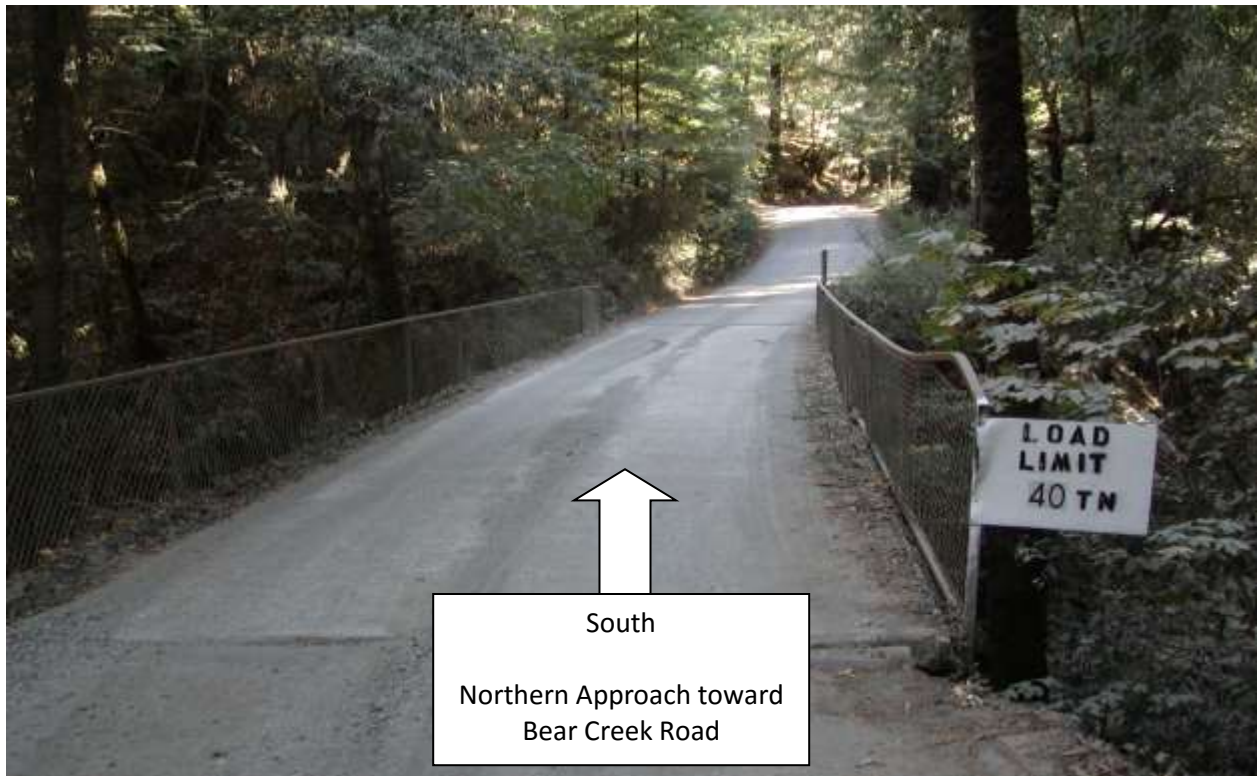
Deer Creek Road First Bridge

The first bridge is a conventional beam bridge with a steel deck covered with concrete. The abutments are concrete. The bridge is rusty but otherwise in good condition. The abutments show no signs of any kind of distress.

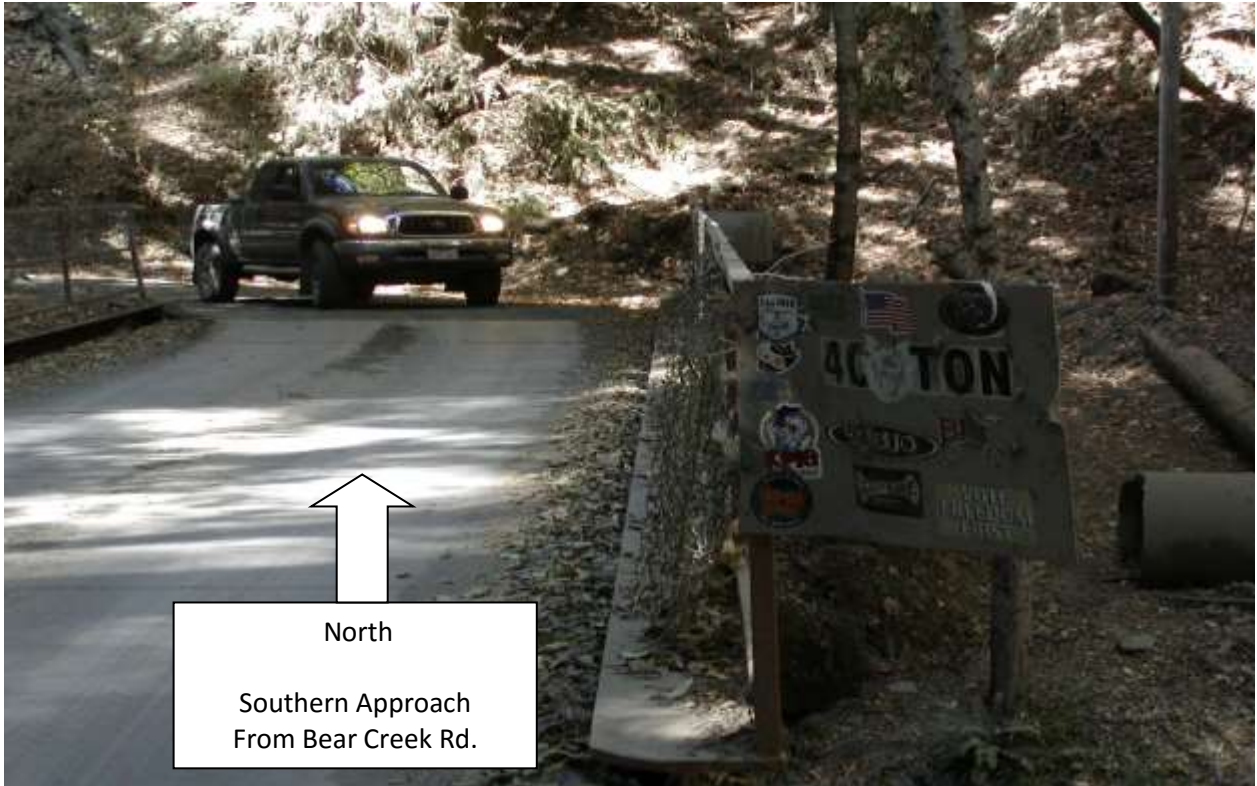
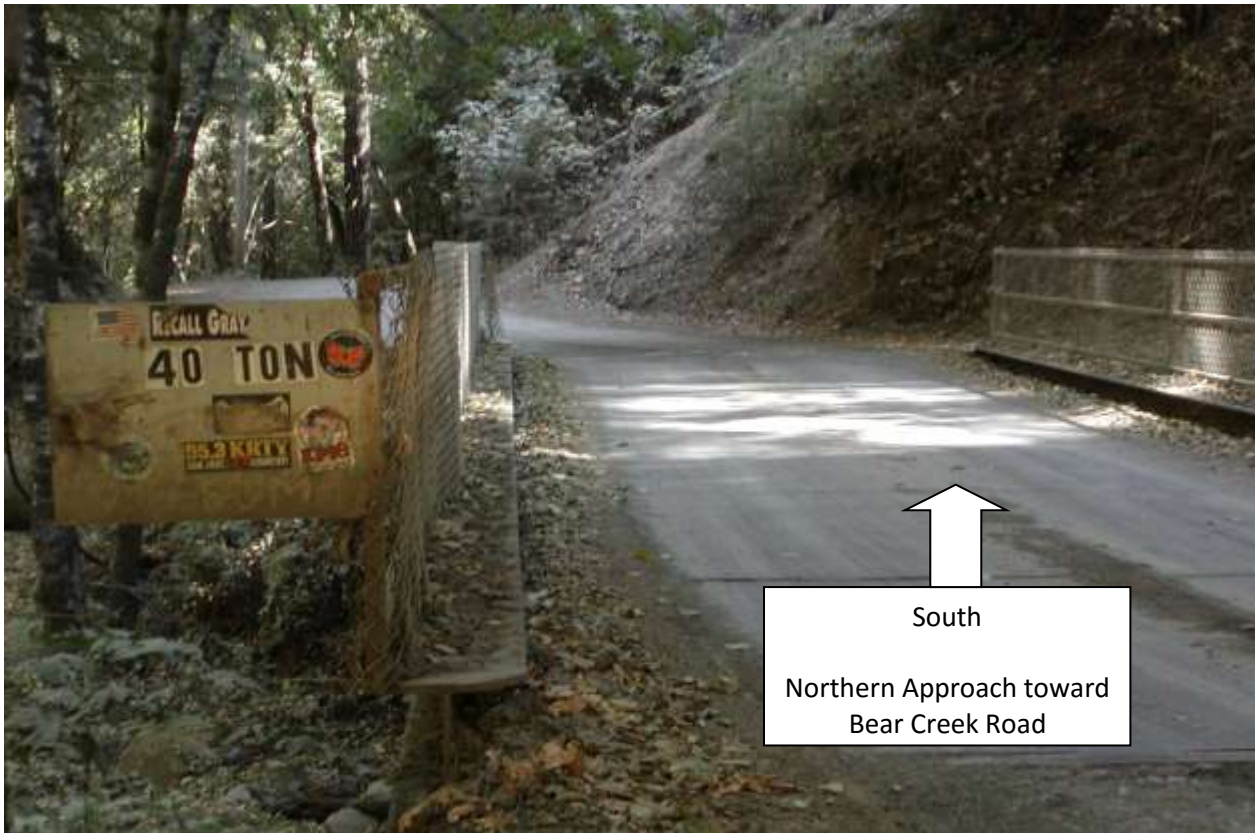
Deer Creek Road Second Bridge

The second, third and fourth bridges are Daniel Bridge – fabricated and installed by Daniel Steel of Ukiah CA. These are all steel beams supporting steel crossmembers and steel decks on steel abutments supported on Cast in Drilled Hole piles.

The second bridge has a broken weld between two bridge segments – this leads to an irritating tin can effect but does not harm to function of the bridge in any way.

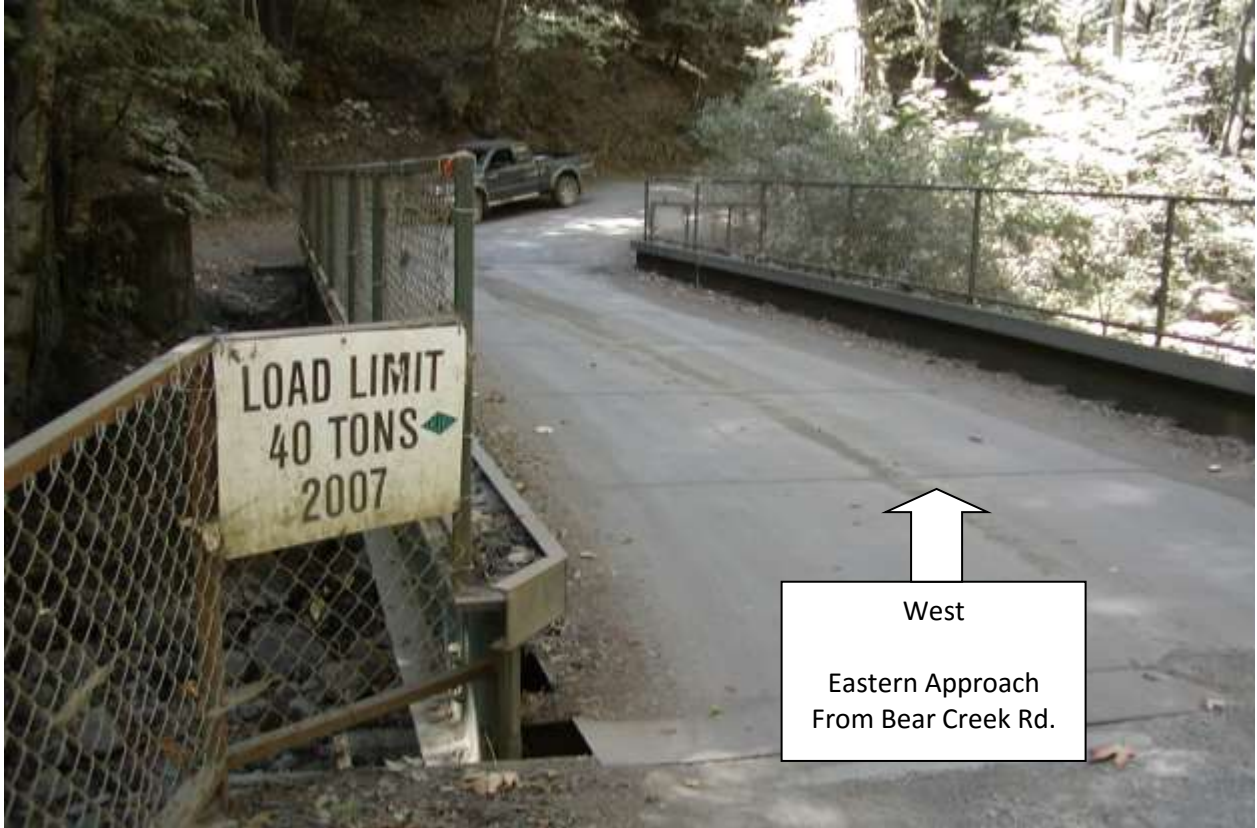
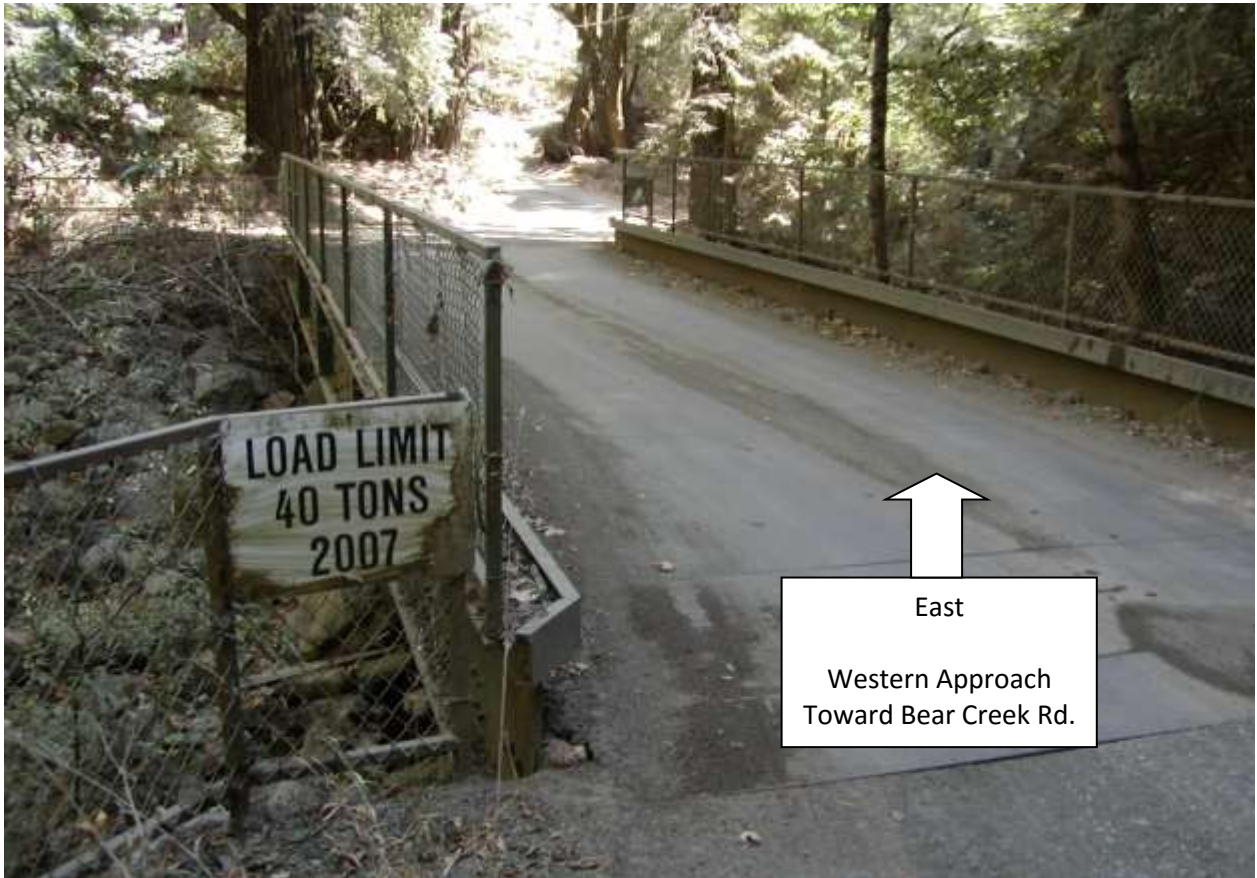
Deer Creek Road Third Bridge

The third and fourth bridges are without obvious faults.
